3rd Australasian Engineering Heritage Conference 2009

Preservation by Operation: Experience of the Restoration and Operation of Large Stationary Steam Engines and the Implications for the Professional Engineer.

John S. Porter B.Sc., C.Eng., F.I.MarEST.

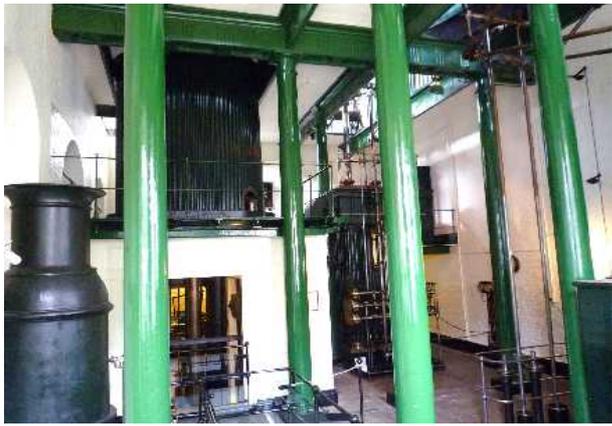
Figure 1. Cornish engines at Kew Bridge, London

At Kew Bridge Steam Museum there are five non-rotative Cornish cycle engines still in their working positions, with cylinders 64, 65, 70, 90 and 100 inches in diameter. Four have beams to connect the steam piston to the pump ram, the other is a "Direct-acting" or "Bull" type engine with the piston and pump ram on a common rod. There are also four large rotative water pumps brought in from other sites.

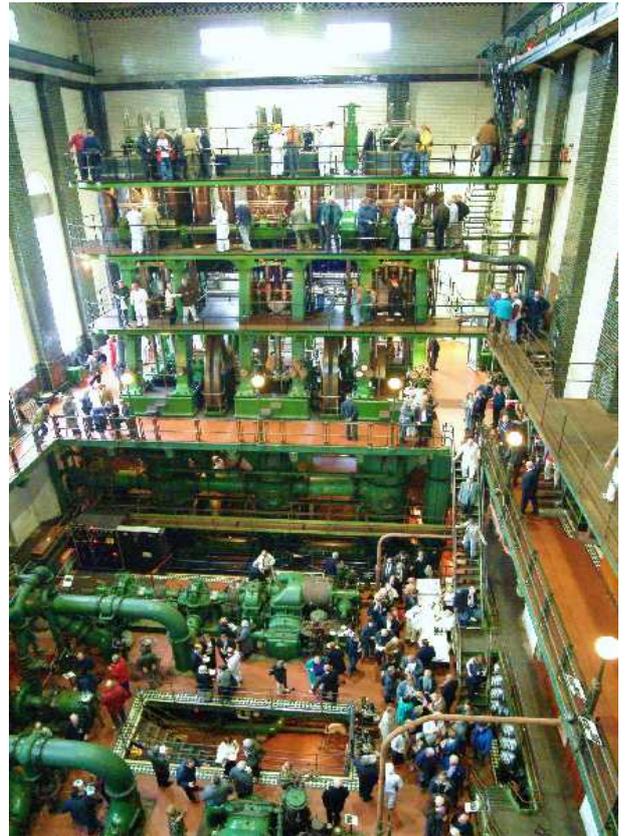
Figure 3. Kempton Park engine

Thames Water (TW), as successors to the MWB, were landed with a problem when their pumping station at Kempton Park was designated as a National Monument and they were required to keep and maintain the building and its contents. This plant was in service till 1980, having been commissioned in 1929. It contains the two largest triple expansion engines ever built in the UK plus two turbine-driven centrifugal units. The engines are 62 feet (18.9m) high and are fully visible when entering the building. The impact of their size is unforgettable. Each engine weighs about 800 tonnes and

is probably the most sophisticated reciprocating steam engine ever built, certainly in the UK.

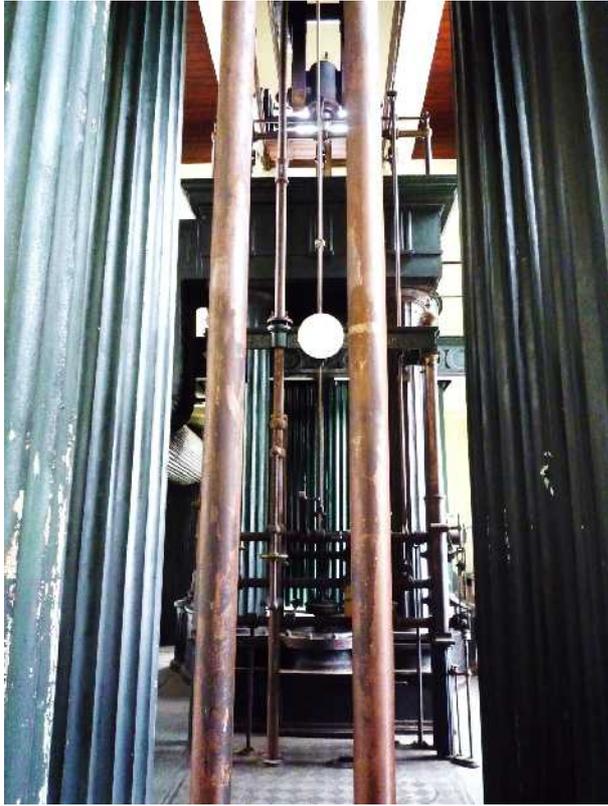
Figure 4. Kew Bridge 100" engine

There is one engine at Kew Bridge that has not yet been touched. It is the 100 inch engine; that is, the cylinder diameter is 100 inches, easily converted to 2540 millimetres though the accuracy to the last 10 millimetres must be doubtful. The stroke is around 11 feet (3.35 metres). It was last in steam in about 1957.

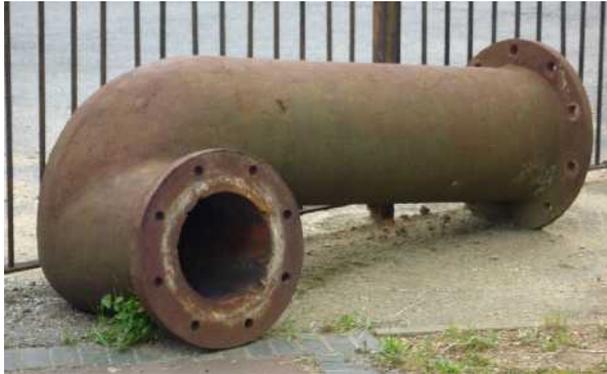
Figure 5. Kew Bridge steam pipe

Most of the restorations at Kew Bridge predate this Charter and there is very little record of what was done. A significant amount of the work was irreversible. Here is the cast iron steam supply pipe for Kew Bridge’s Bull

engine which had to be replaced in steel to meet modern insurance requirements. The discarded pipe is neither protected nor interpreted.

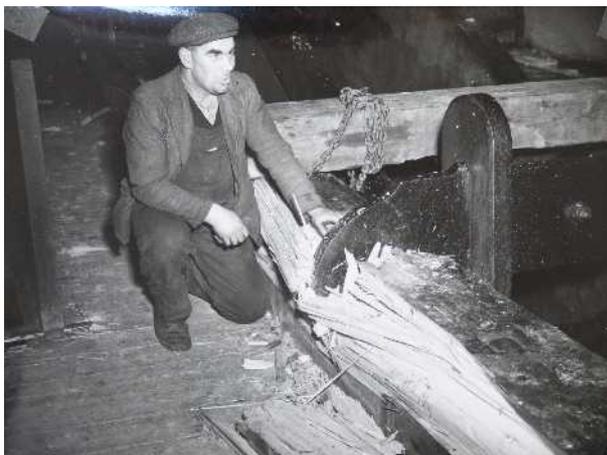
Figure 6. Smashed spring beam

Although not a museum engine, Figure 6 gives some idea of the forces involved when a Cornish non-rotative engine gets out of hand.

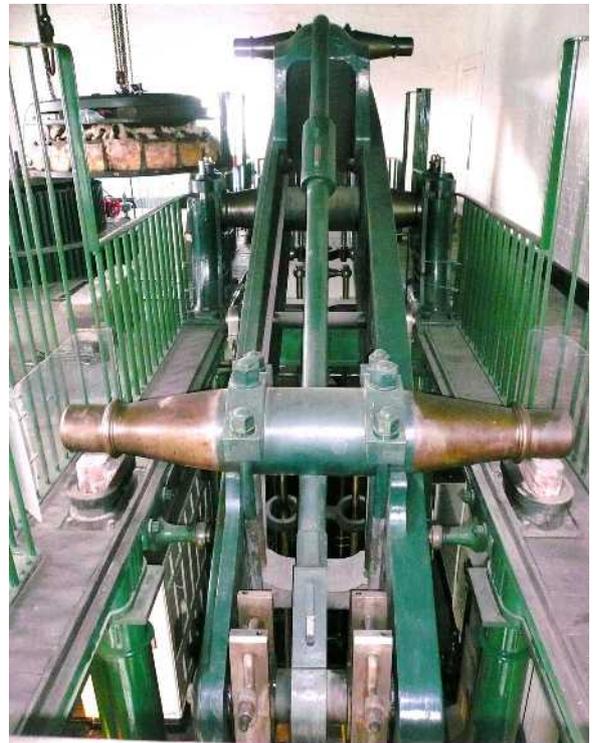
Figure 7. Maudslay beam

The two halves of the beam look right, but what design calculations were used? Were they just laid out on the foundry floor by the Head Moulder according to his eye and instinct? I can find very little evidence of real stress analysis or component testing in the 19th century. The evidence given to the enquiries into the Hartley Colliery disaster in 1863 (204 dead) and the Tay Bridge in 1879 (75 dead) are remarkable for their lack of information on how the failed cast iron components were designed and then tested both during and after manufacture. Coincidentally, there were failures of cast iron beams at Kew Bridge in both 1863 and 1879.

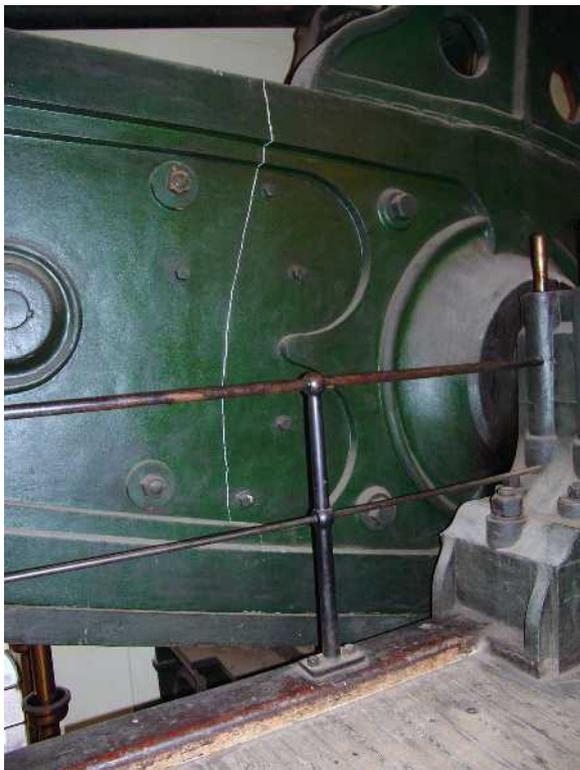
Figure 8. Crack in 100" beam

When a half beam on the 100 inch engine failed in 1879 after only seven years service there was no apparent cause. The crack started in the top flange, close to the centre of the beam, developed through the web and had reached the lower flange when it was spotted and the engine stopped, fortunately without any serious consequences.

The repair consisted of holding the cracked parts in position by a light doubling plate and enclosing each half beam in a system of wrought iron bars with a bridle. The bars were tensioned to put the cast iron into compression by flogging up cotter bars in the joints. One of the fire welds on the wrought iron bars failed three years after installation and this too was repaired. The engine ran like that for a further 63 years under full load.

Now the debate is whether this engine should be restored simply for the education and entertainment of visitors, and for the gratification of those who will undertake the work. The engine had been tested under load for 63 years, and this load will be substantially reduced for museum operation. "What's the problem?" is the normal reaction. Technically, there isn't one, yet I personally feel uneasy about putting this beam back into service, even in museum conditions. How do we know the crack is arrested? Are there any other cracks or stress raisers in the beam? Is the wrought iron trussing effective? The evidence of the strain gauge test on the 90" engine's beam is that the wrought iron system has long since relaxed and is not applying any compression forces.

These questions can be tackled but at what cost, both in cash and in damage to an historic artefact? The fact that the engine ran for 63 years in this condition is history itself. The suggestion, which has been made seriously, that it be welded, or a metalock repair applied, is just not a starter.

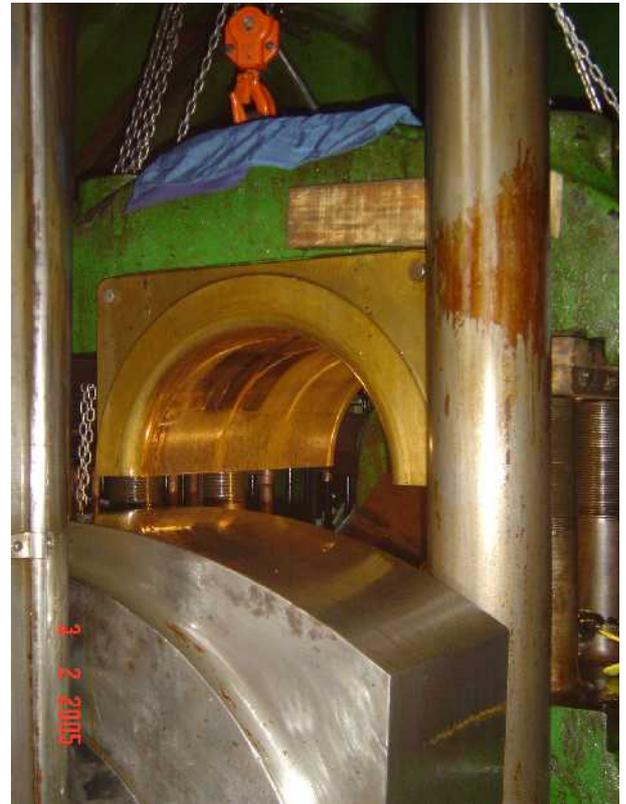
Figure 9. Kempton engine main bearing.

The first to suffer was the main crankshaft bearing supporting the over-hung LP crank. Smoke appeared and friction slowed the engine. It was relatively straightforward to inspect the top half but the load carrying lower half could not be so easily accessed. Maintainability was not a factor in the engine designer's mind in the 1920s!

Eventually it was accepted that the lower half of the bearing would have to come out. This meant bringing in a contractor who built a frame with rolled steel joists so that the crankshaft, the LP cylinder running gear, and the flywheel could be lifted with hydraulic jacks just sufficient to take the load off the bearing. After lifting the shaft, it took a complete day to turn the bottom half of the bearing out of the bed plate. No serious damage was found and the journal and bearings could be cleaned up by hand stoning and scraping. A long and tedious job, One interesting aspect of all this was that the drawings showed that all the load carrying halves of the crankshaft bearings had oil grooves cut in them. When the bearing was finally removed, it was found to be plain. Written evidence in Worthington-Simpson's archives shows a request from their erection engineer for a new bearing and crankshaft lifting gear during commissioning. Conventional wisdom is that the load carrying capacity of hydrodynamic bearings of this type is reduced by the presence of oil grooves and this would account for the replacement bearing being plain. There

is no record of further problems with this bearing during the engine's working life.

To minimise the risk of dry pick up after the winter lay-up, and reduce the time required to build up the hydrodynamic film during the frequent starts that the engine is now subject to, a horizontal drilling was put through the bearing shell at the six o'clock position with an outlet in the middle of the bearing. Prior to each start, oil is pumped in with a hand pump.

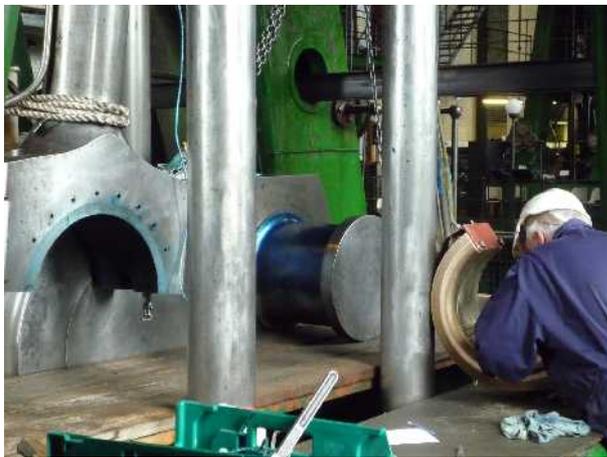
Figure 10. Kempton engine crankpin bearing.

During a test run in March 2009 prior to the start of the season, this bearing showed signs of distress; smoke and rapidly rising temperature. It was necessary to get another jacking system in to lift the weight of the piston, crosshead, connecting rod, pump rams and rods off the pin to allow both half bearings to be inspected.

In spite of repeated scraping, adjustments, and opening up of clearances, this bearing is still overheating. It may have been damaged by rather complex factors, including too much adjustment by scraping. The engine is still being demonstrated with care, and slowly, with the bearing being monitored continually with thermocouples, but much more work, and thought, is required for this coming winter.

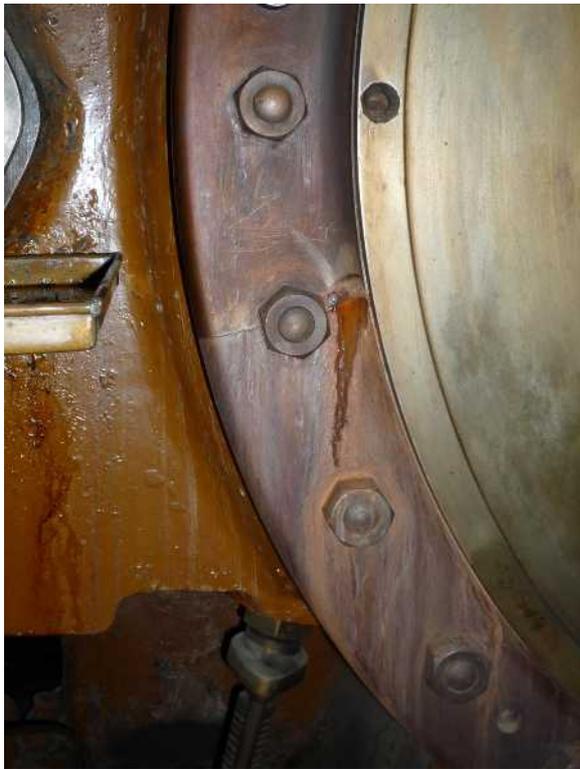
Figure 11. *Cracked LP cylinder cover*

Figure 11 shows the results of a careless, or inadequate, warm-up procedure on a 1910 rotative engine. And the rate at which an engine without any remaining pumpwork will accelerate requires sensitivity and anticipation in handling the throttle.
